# MDSS Winter Storm Report: 25-27 Jan 2004

## *Meteorological Summary*

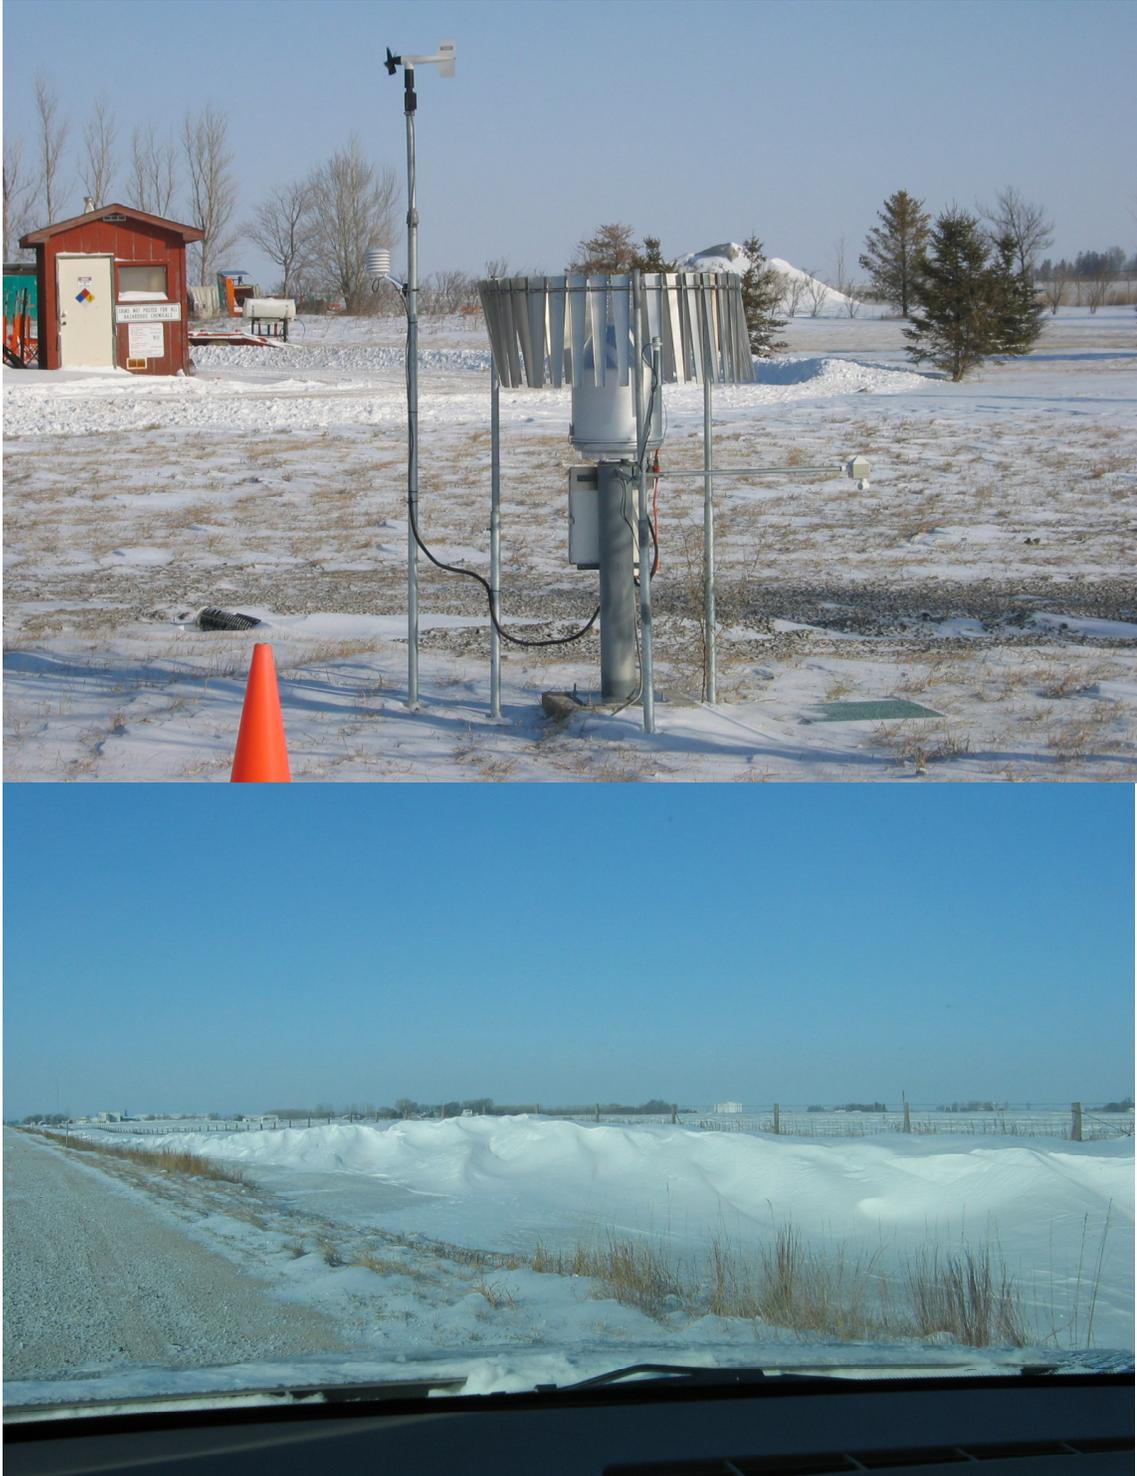
**Figure 2.** Weather sensor site at Ames garage (top) and a snow bank along US-30 three miles east of Ames garage. Both pictures were taken around 1000 CST on 27 January.

Precipitation lasted from Sunday evening through early Tuesday morning. During most of the period, snowfall was light. By Monday morning, approximately 2.5 in of snow had fallen at the Ames garage location, based on measurements made by the MDSS lab observer, Brent Shaw. Throughout the day on Monday, snowfall was light and intermittent. A brief period of moderate snow occurred late Monday night, from approximately 2200 CST to sometime after midnight. Final snowfall totals for Ames remain in question as significant blowing and drifting occurred. The National Weather Service (NWS) forecast office in Des Moines showed an official storm total of 7.9 in for Ames (see Fig. 1). At the garage location, snowfall would appear to have been less, perhaps closer to the 4 or 5 in range. Fig. 2 shows photographs taken Tuesday morning after the precipitation had ended. In Fig. 2a, the snow pad below the ultrasonic snow depth instrument (located at the Ames garage) is completely clear of snow due to the wind. Also note the grass showing through the snow, which would lead one to believe snowfall totals were much less than the 8 in reported by the NWS. Fig. 2b shows an embankment on the north side of westbound US Highway 30 (hereafter referred to as US-30) located a few miles east of the Ames garage. Note the large drifts which would lead one to believe this was a significant snowfall event.

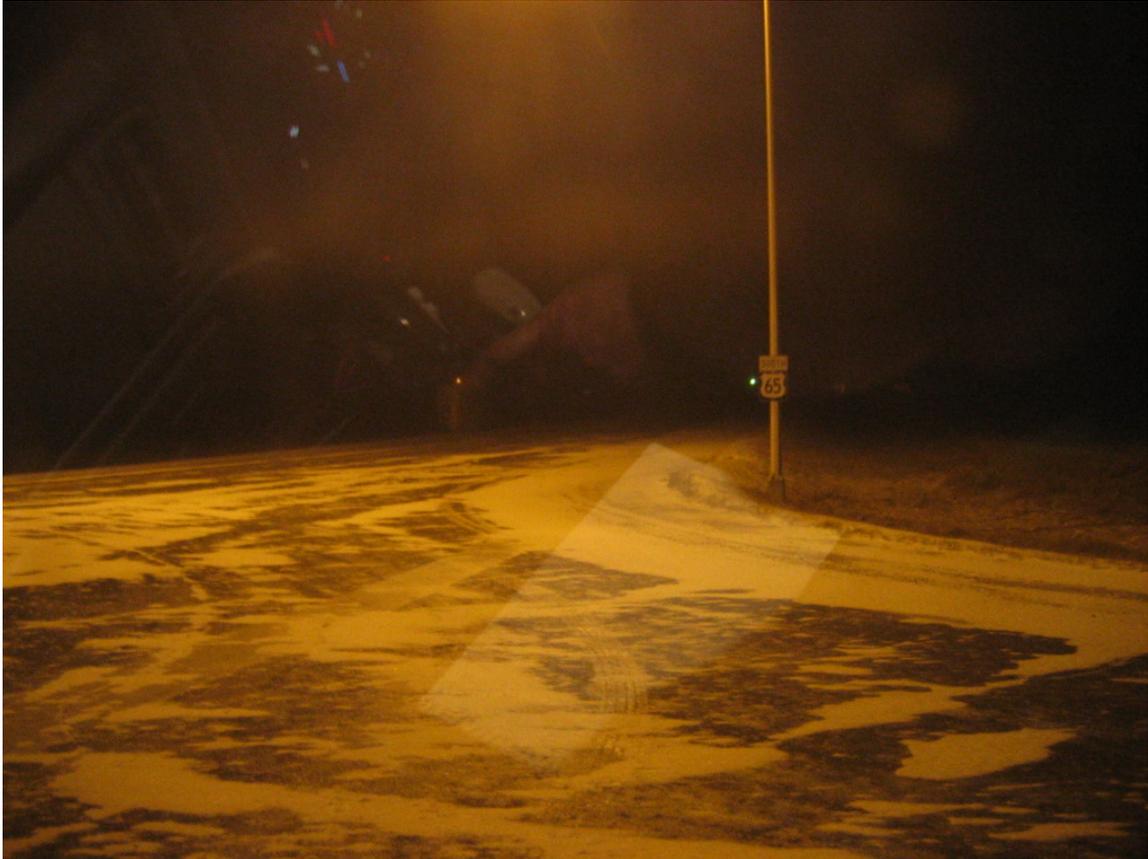
**Figure 5.** US-30 at US-65 junction near Colo at 0130 CST, 26 January 2004.

The final leg was from eastbound US-30 from I-35 to Colo and back. While also becoming snow covered, the coverage was less than the western segment of US-30 because of less intense snowfall. Fig. 5 shows a photograph of the US-30 road surface at the US-65 junction near Colo taken during this leg around 0130 CST on the 26<sup>th</sup>.

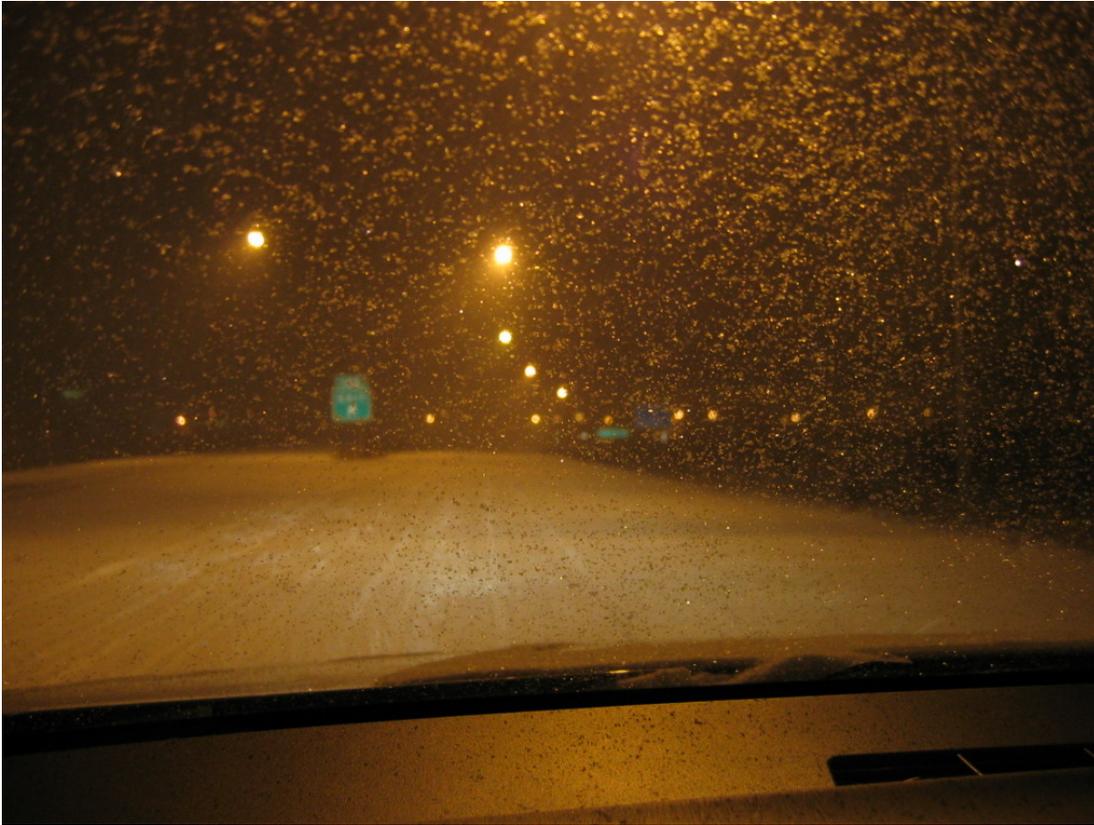
**Figure 7.** Photo of US-30 west at exit 146 at approximately 0230 CST, 26 January 2004.

After logging some data on the condition of US-30 section in front of the Ames garage and noting weather and pavement conditions, I decided to return to the hotel at approximately 0215 for a 2 hour nap, having been up since 0700 the previous morning. Prior to departing the Ames garage, I shot the nice photo of a snowplow in front of the facility shown in Fig 6, which shows the snow falling and beginning to significantly accumulate. On the drive back to the hotel, I captured the photo in Fig. 7 depicting conditions on US-30 as I approached the exit 146. Note that the US-30 was completely snow covered by this time and was becoming slick.

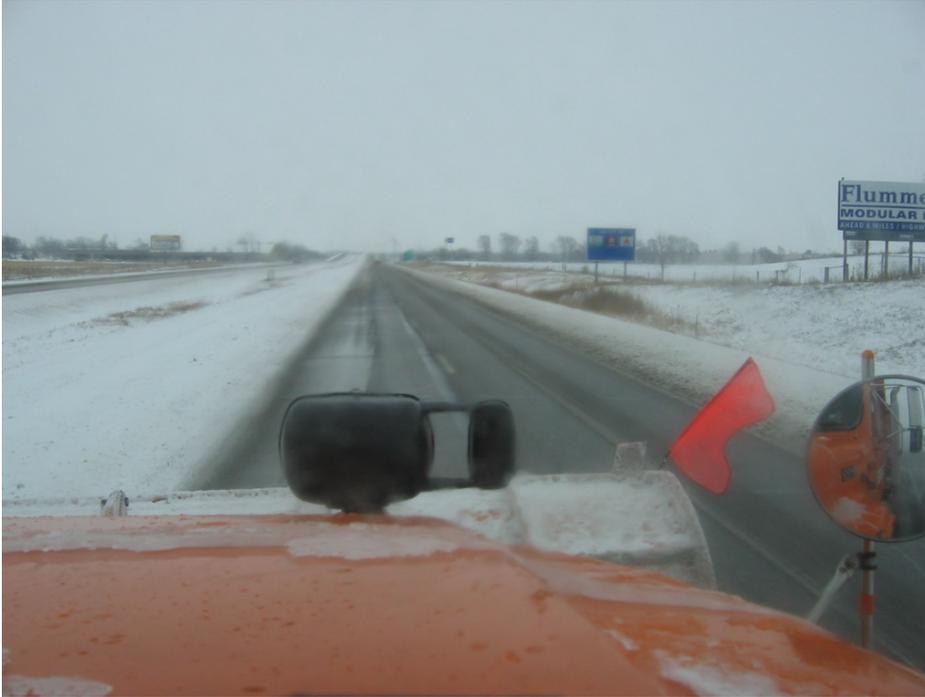
**Figure 8.** View from plow on eastbound US-30 east of the Ames garage. Note wetting of road as a result of prior treatments, despite an 18 F air temperature.

From 1000-1200 CST, I rode aboard the left-wing snowplow assigned to cover US-30. During that period, we covered most of the US-30 segment twice. From 1000-1030, we went east from the garage to exit 144, plowing the left shoulder and treating bridges and elevated lanes with approximately 400 lbs/l-mi of salt. Driving lane was generally 80-90% covered, and the passing lane was nearly 100% covered. From 1030-1100 we covered the portion from the garage out to Colo and back. Some minor indications of wetting from the previous treatment were visible. Finally, by the time we returned to the garage and headed west toward Ames again (approximately 1100 CST), US-30 was becoming mostly wet and slushy. Pavement temps measures on board the plow were running 24-26F with an air temperature of 18 F. As forecast by the morning MDSS, snow tapered off during the late morning and early afternoon. Figure 8 shows conditions at approximately 1145 CST along US-30 as taken from the plow.

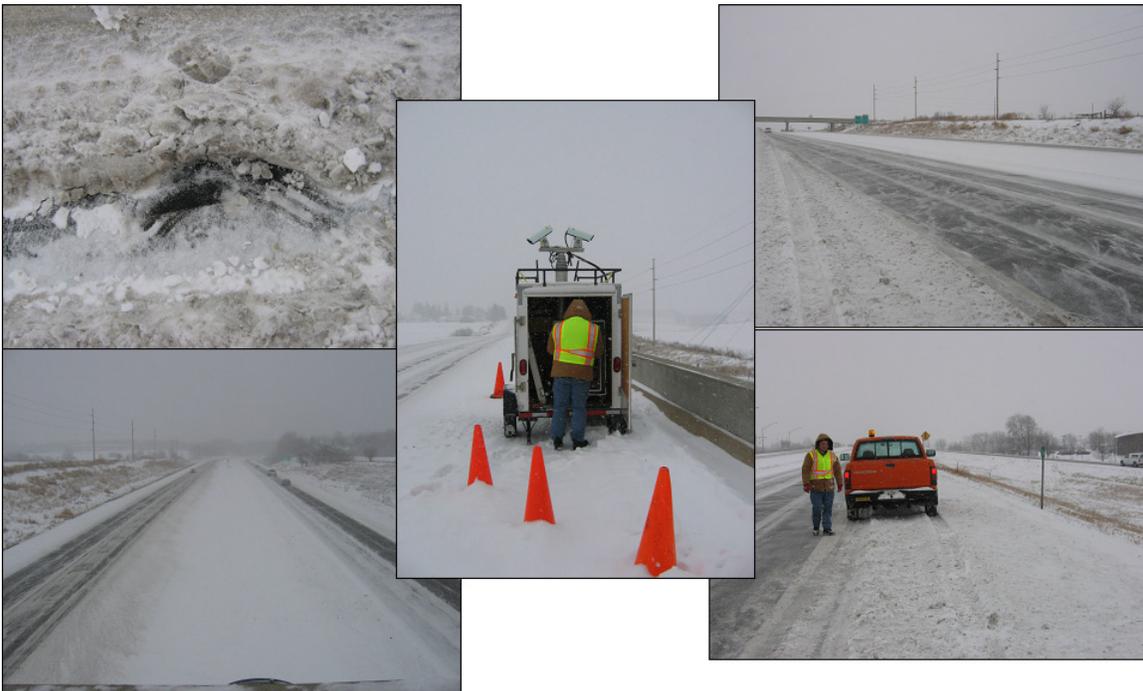
After taking a break for lunch, Dennis Kroeger and I performed some additional data collection activities. Dennis collected tapes from the traffic monitors and we attempted to take 3 brine samples using the tares provided by CCREL. Unfortunately, temperatures continued to fall and snow began to increase again, so areas that had been wet earlier were once again becoming snow covered, and we abandoned the collection of brine samples. Fig. 9 shows some pictures taken during this period of conditions.

**Figure 9.** A variety of photos taken along or by US-30 from 1500-1600 CST, Monday 26 January, while collecting data. Snowfall was on the increase again as temperatures continued to fall into the teens. Center picture is on the State Avenue bridge at the autoscope site overlooking US-30. Lower-left is the view of US-30 toward the east from the autoscope site.
